Property Inspection Report

1234 Any Road
Geneva, IL 60134

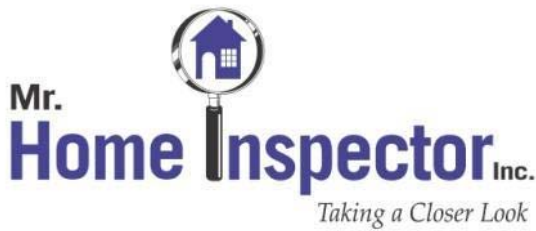
Mr. Home Inspector, Inc.

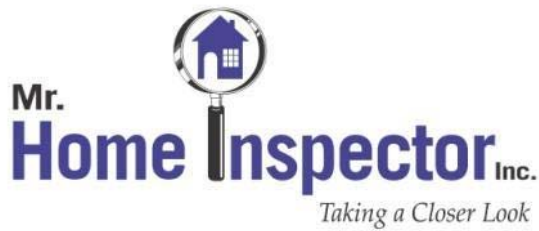
Mr. Home Inspector, Inc.

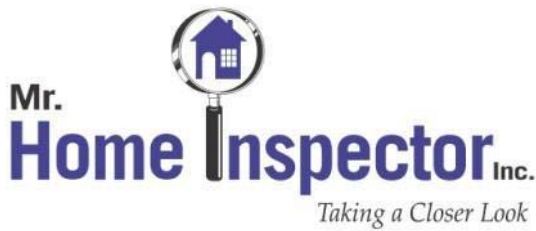
Mr. Home Inspector, Inc.

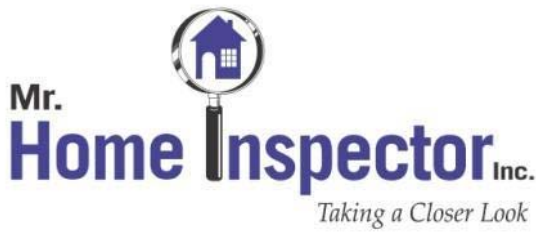
Mr. Home Inspector, Inc.

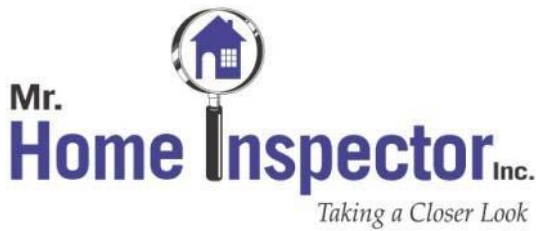
Mr. Home Inspector, Inc.

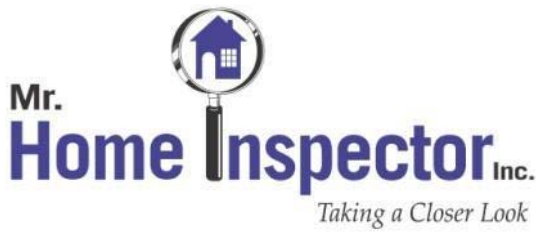
Mr. Home Inspector, Inc.

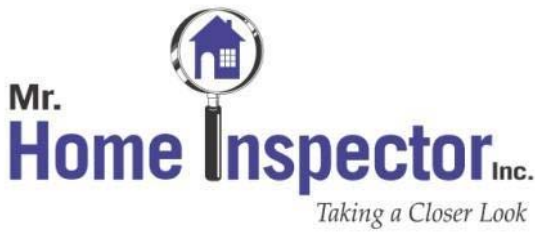
Mr. Home Inspector, Inc.

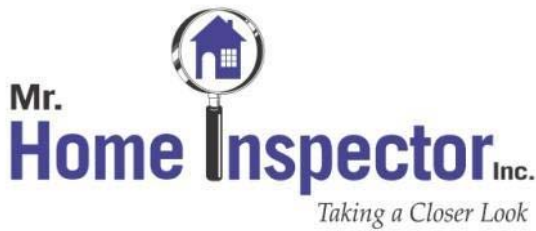
Mr. Home Inspector, Inc.

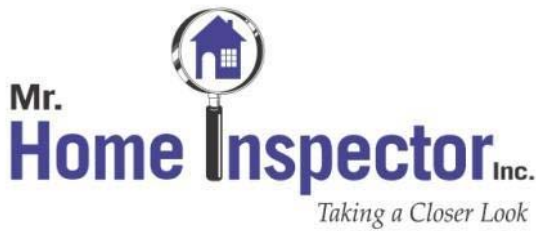
Mr. Home Inspector, Inc.

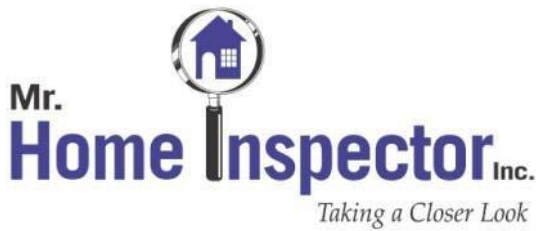
Mr. Home Inspector, Inc.

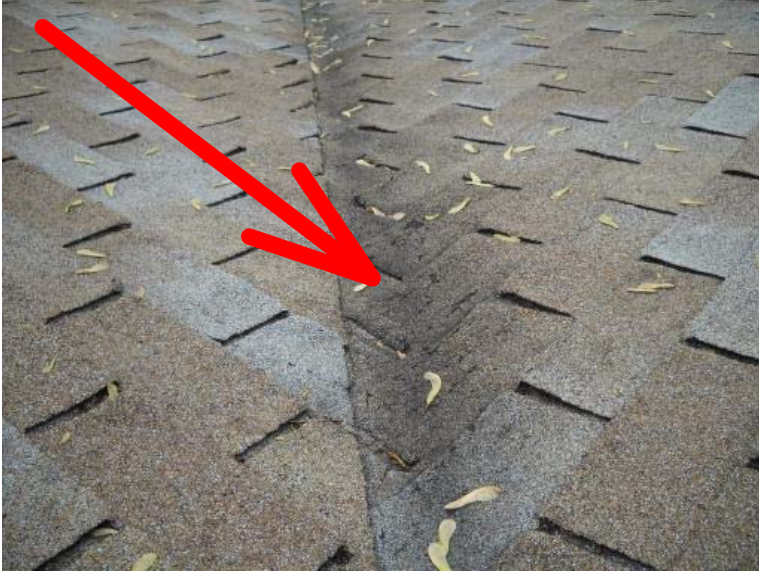
The valleys of the roof are worn with deteriorating shingles. See recommendations under the main roof.

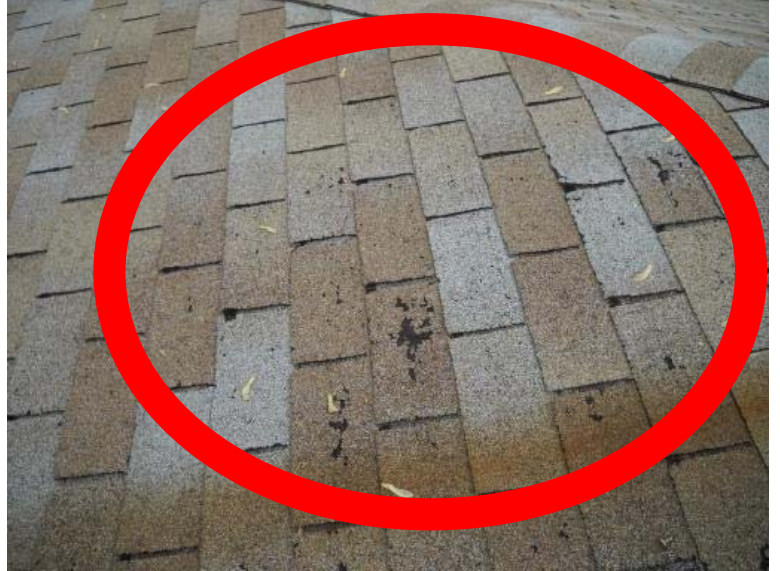
The main roof surface and the flat roof area have signs of worn out shingles and loose seams on the flat roof. Recommend replacement in the next 2-3 years.

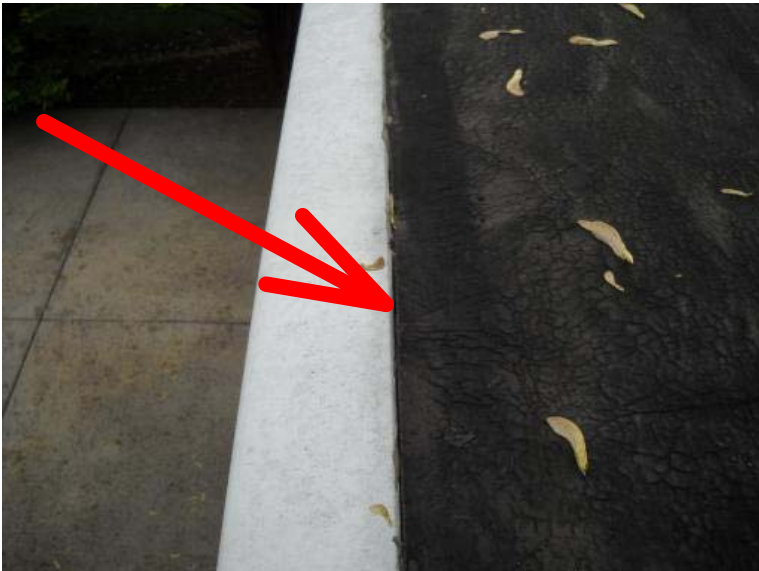
The main roof surface and the flat roof area have signs of worn out shingles and loose seams on the flat roof. Recommend replacement in the next 2-3 years.

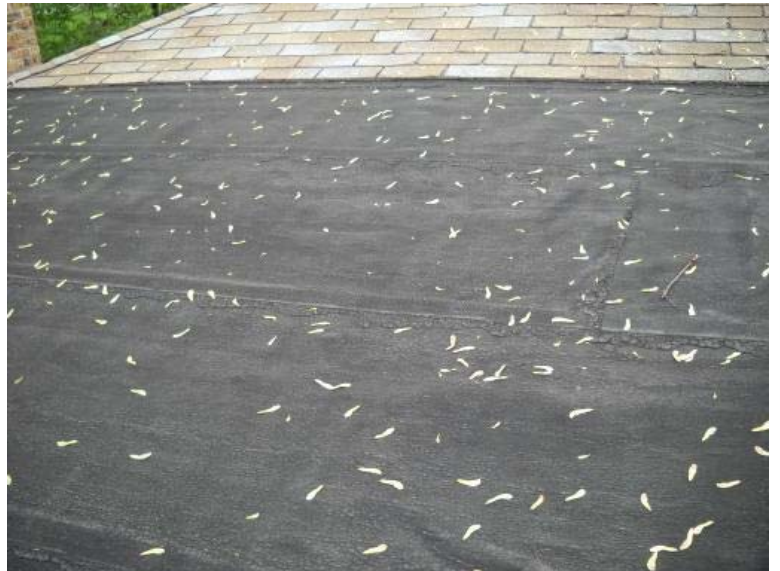
The main roof surface and the flat roof area have signs of worn out shingles and loose seams on the flat roof. Recommend replacement in the next 2-3 years.

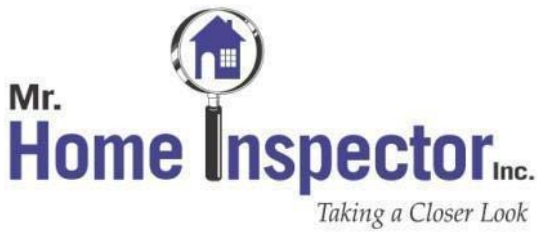
Mr. Home Inspector, Inc.

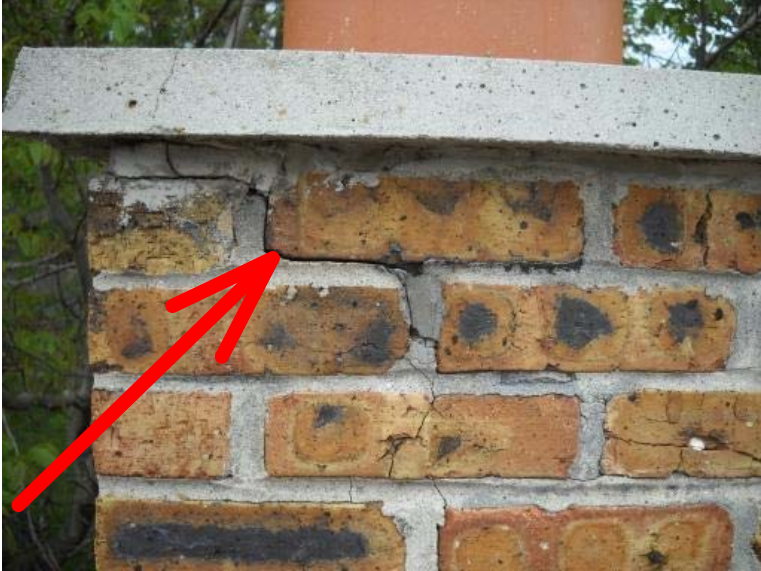
Bricks have broken or popped surfaces with cracking mortar joints. Recommend repairs be made by a qualified masonry contractor.

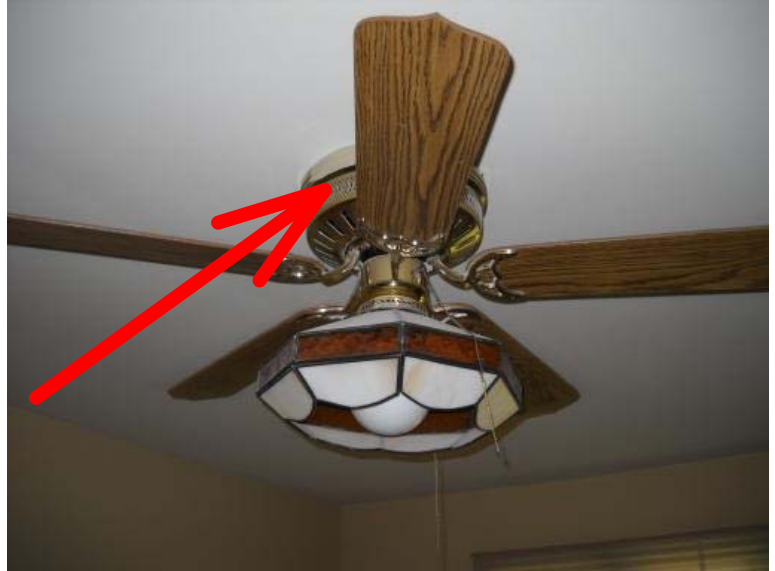
The ceiling fan in the master bedroom is loose at the ceiling mounting. Recommend repairs be made for safety.

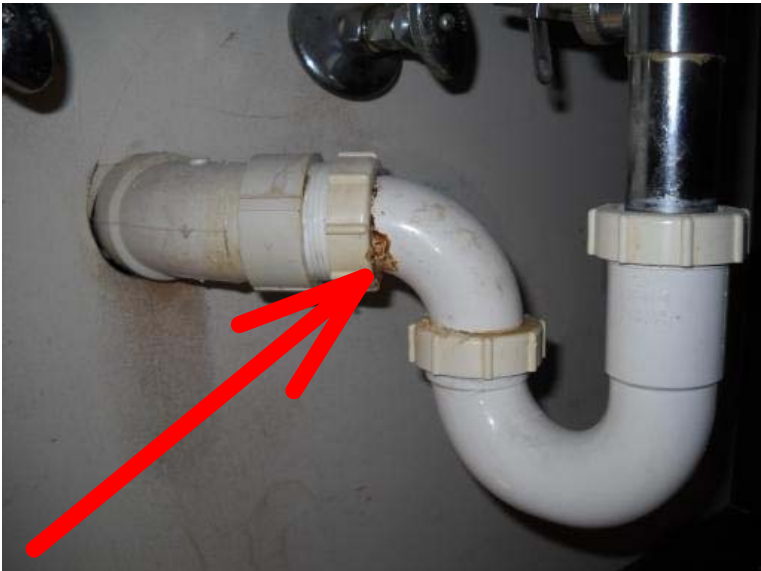
The right side sink drain connection has an active water drip from the rear drain pipe in the upper hall bathroom. Recommend repair.

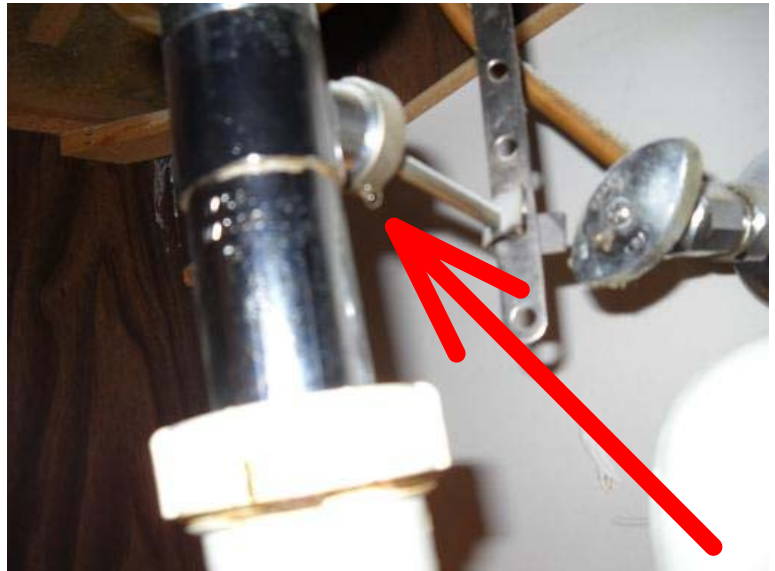
The left sink drain stopper connection under the sink in the upper hall bathroom has an active water drip into the cabinet area. Recommend repair.

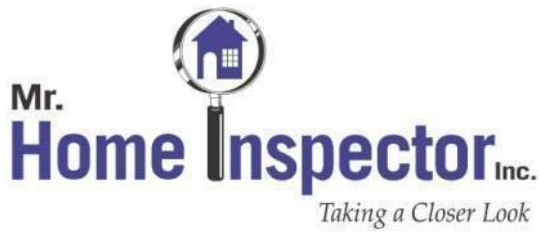
Mr. Home Inspector, Inc.

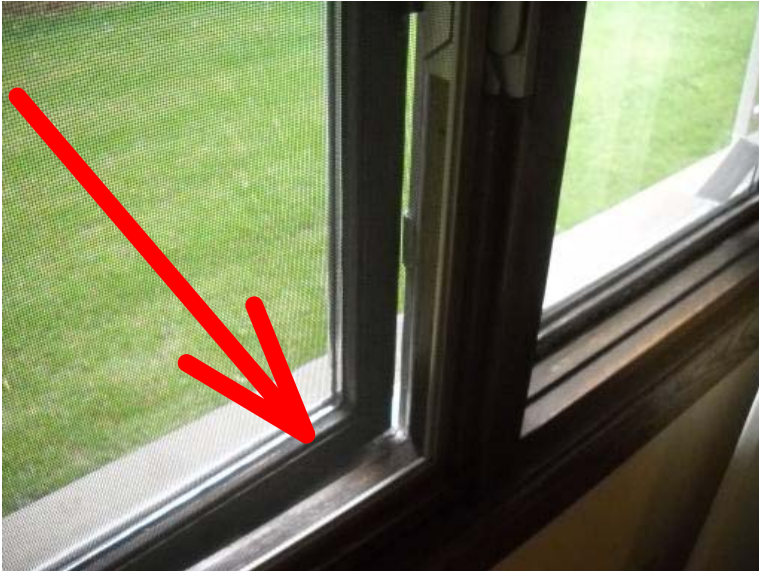
The left window in the dining room will not open properly. It appears the lower sill plate is warped. Recommend repairs be made to the window.

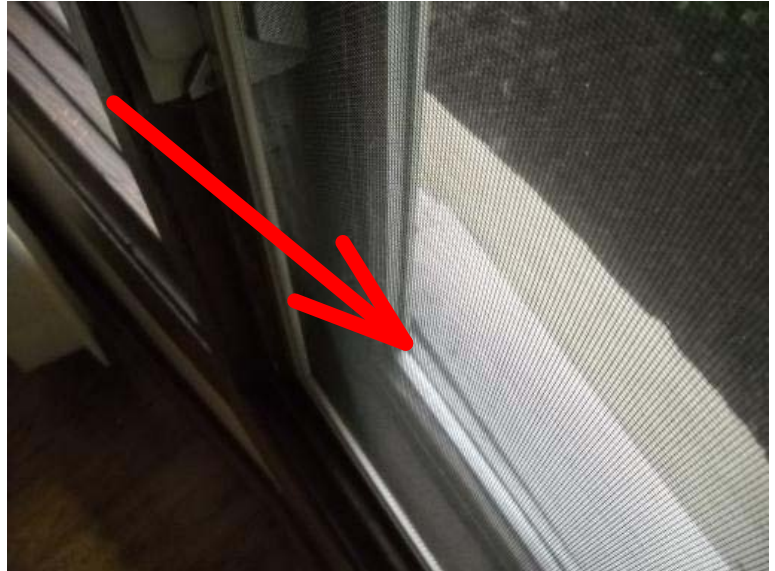
The front living room casement windows bind on the lower exterior window trim and the left window casement is stripped. Recommend repair.

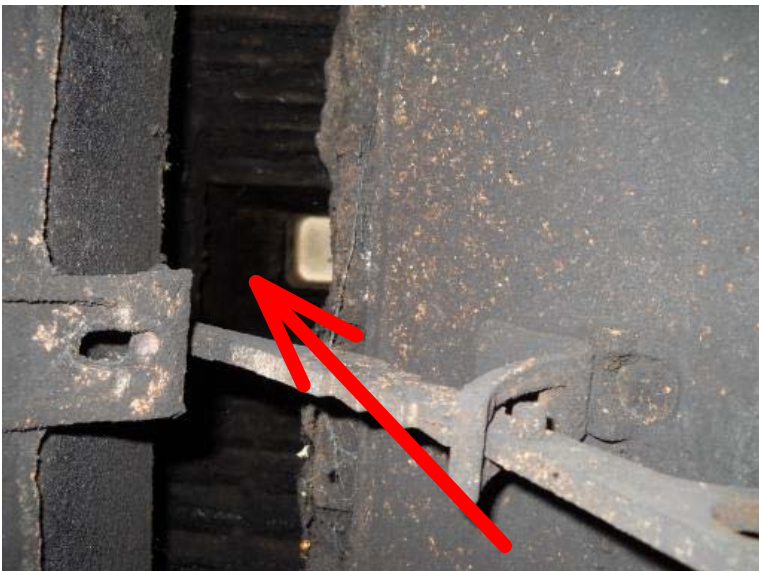
Cleaning of the flue and it's internal components are recommended annually to maintain safety and efficiency of the fireplace.

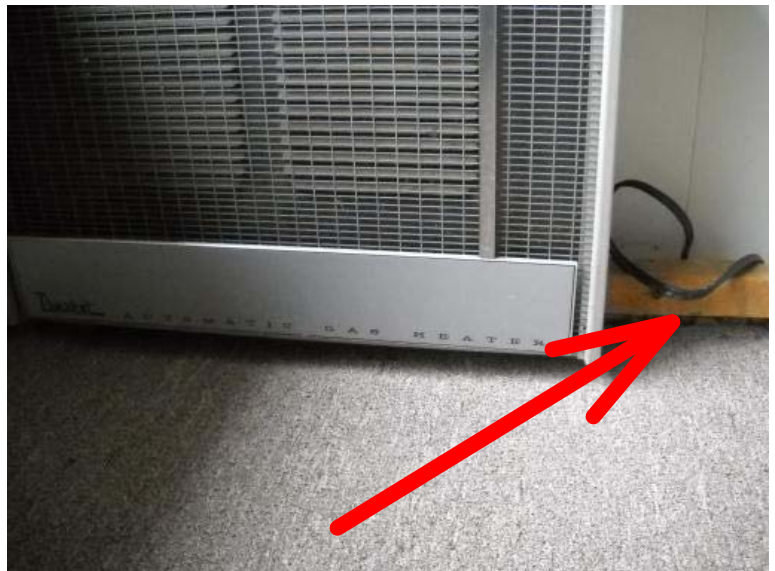
The wall unit heater in the rear sun room has the gas supply turned off and was not able to be function tested. Recommend verifying proper operation prior to closing with the current home owner.

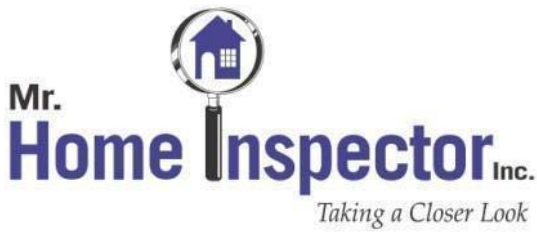
Mr. Home Inspector, Inc.

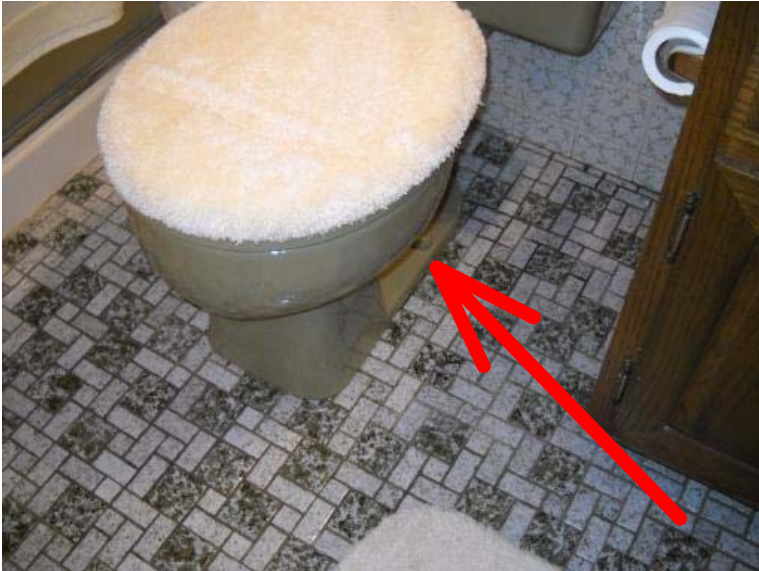
The toilet is loose at the floor mounting in the lower hall bathroom and leaks into the basement behind the furnace. There is subflooring damage at the base of the toilet. Recommend having a licensed plumber evaluate and repair prior to using.

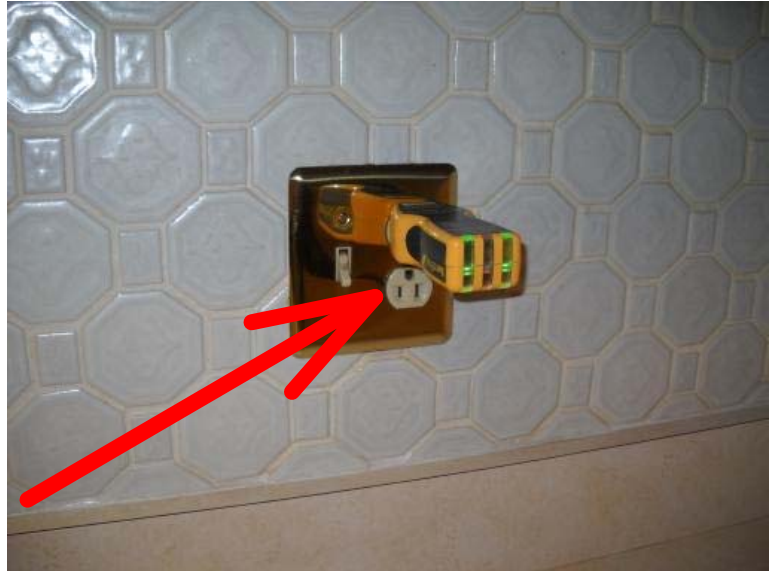
Non-GFCI circuit at the kitchen wall outlets. Recommend a qualified electrician install a GFCI outlets for safety near water.

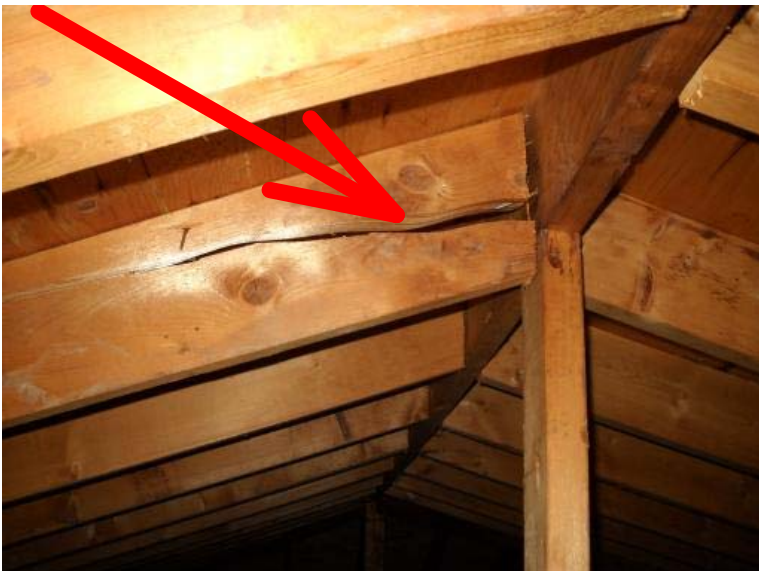
There is a broken roof rafter at the middle front attic area of the laundry room. Recommend having a qualified contractor repair the rafter for proper roof support in this area.

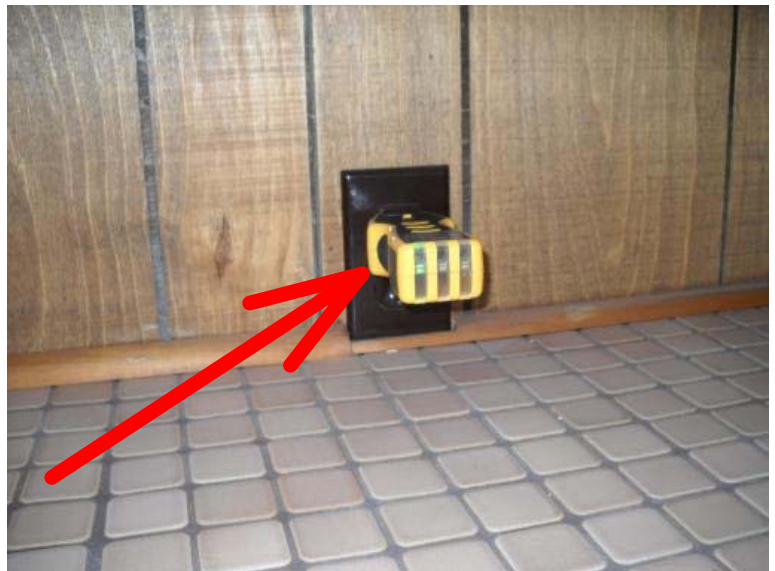
The wall outlet at the left rear corner of the bar area is wired incorrectly with an open ground. Recommend repairs be made by a qualified electrician.

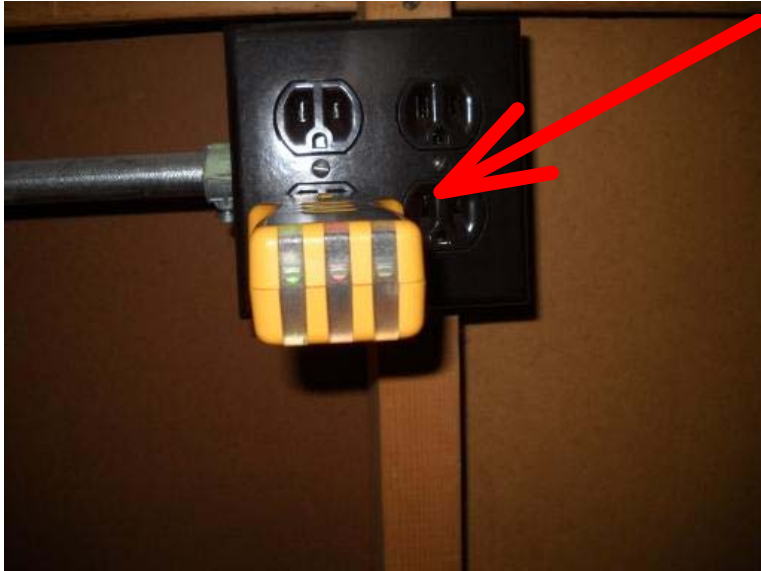
The four bank wall outlets at the bar are wired incorrectly with the hot and neutral wires reversed. Recommend having a qualified electrician properly wire the outlets.

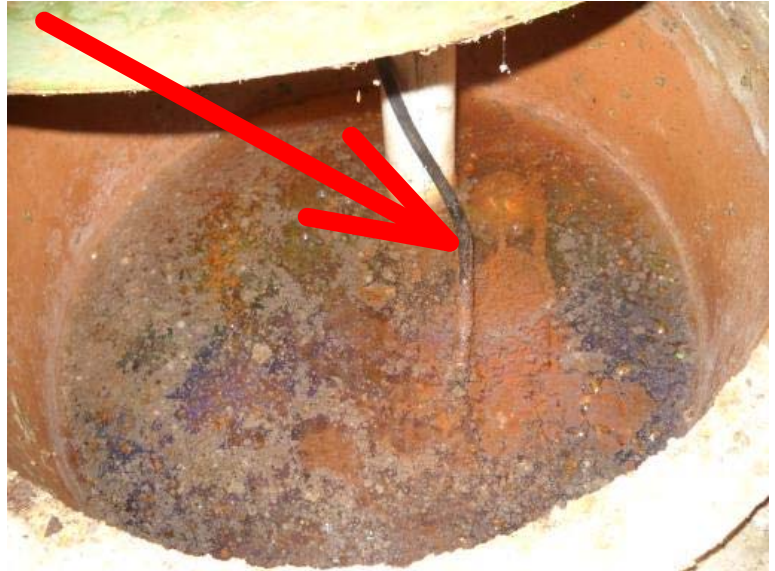
The basement sump pump pit is full of water and the pump will not work when activating the float switch. Recommend evaluation and repair or replacement of the sump pump by a licensed plumber.

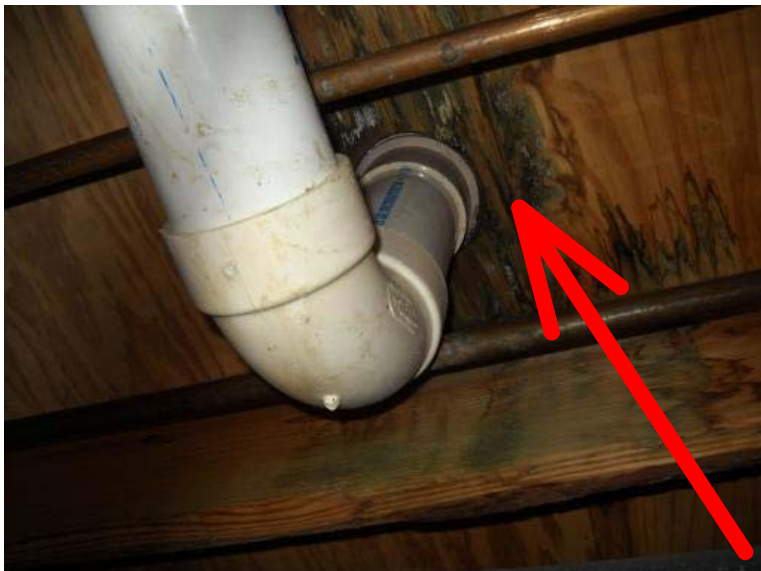
The plywood subflooring is moisture damaged under the lower hall bathroom toilet. Recommend replacement of the subflooring when the toilet repairs are performed.

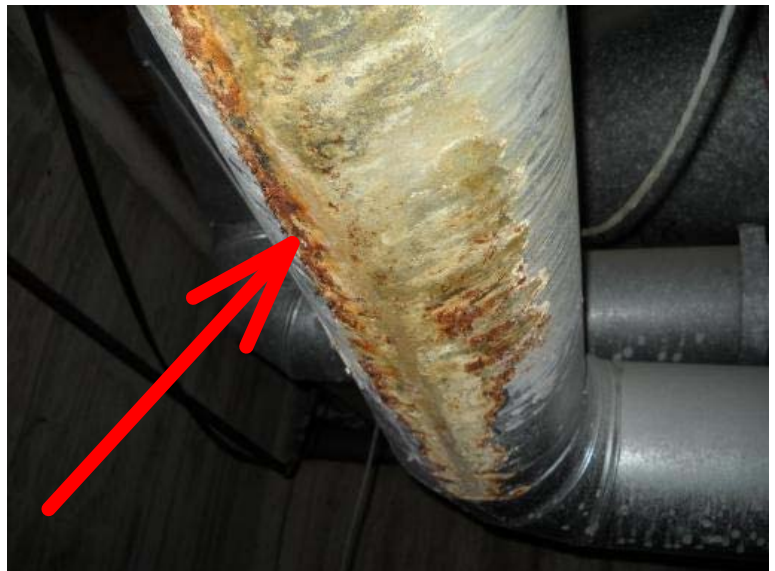
The heating return duct behind the furnace is rusted through on the bottom side from the toilet leak. Recommend having a qualified heating contractor replace this section of the duct work.

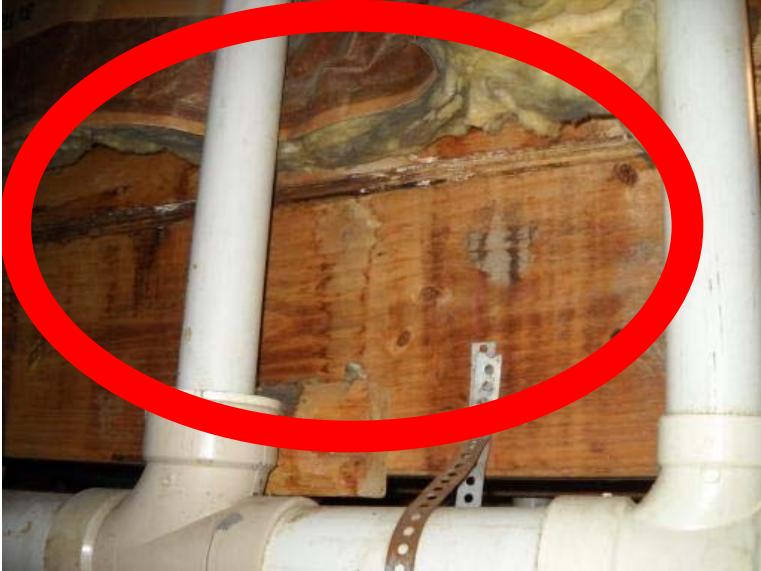
At the basement behind the furnace there are previous water stains from he shower pan in the lower hall bathroom. These stains were dry at the time of the inspection. Recommend monitoring this area for possible leaks and future repairs.

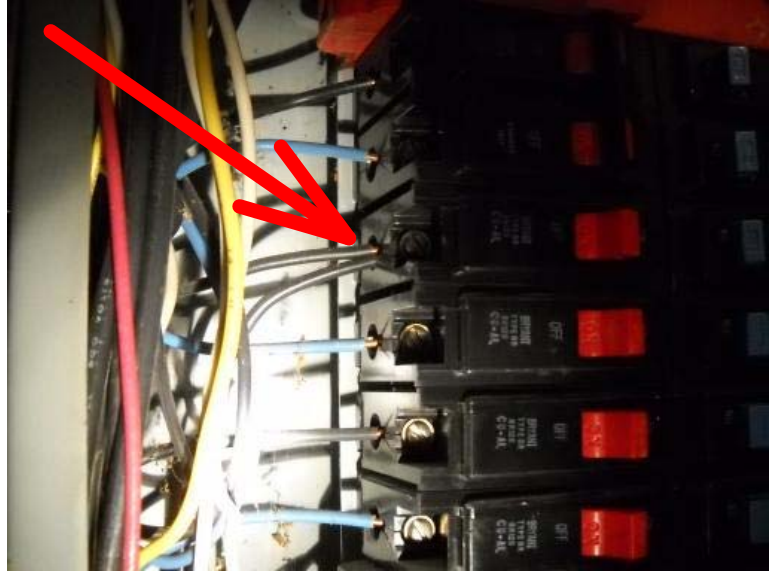
" A double tap, which can result in loose wire connections and possible overheating, was noted. Further evaluation by a qualified electrician is recommended".

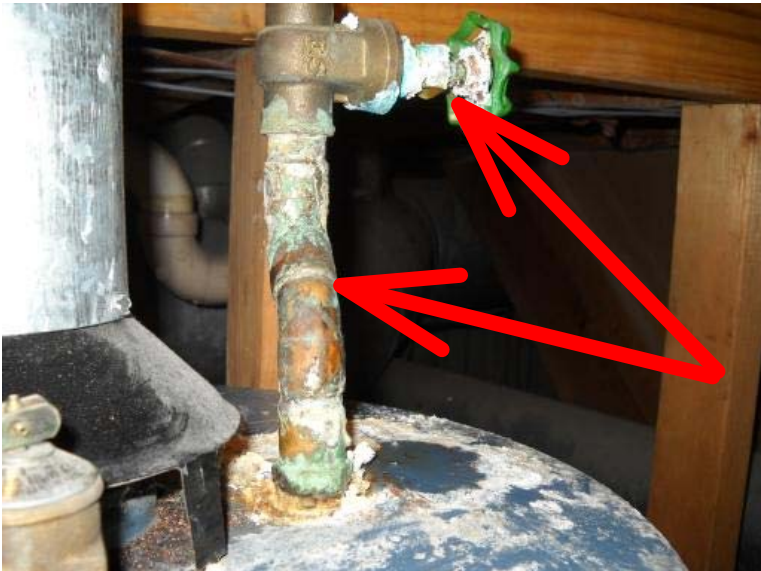
The water shut off valve at the water heater has an active leak and the supply line is corroded. Recommend repair or replacement of the water shut off valve and line by a licensed plumber.

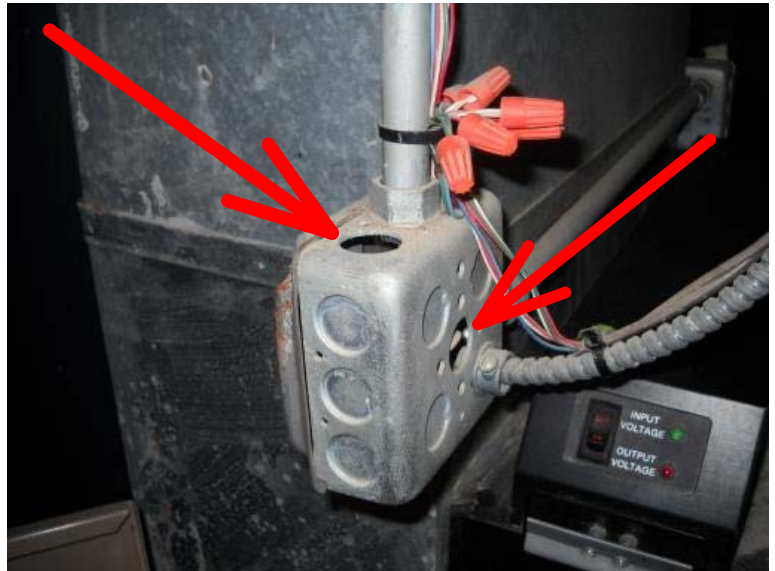
The junction box near the furnace has open knock out holes. All knock outs should be capped for safety.

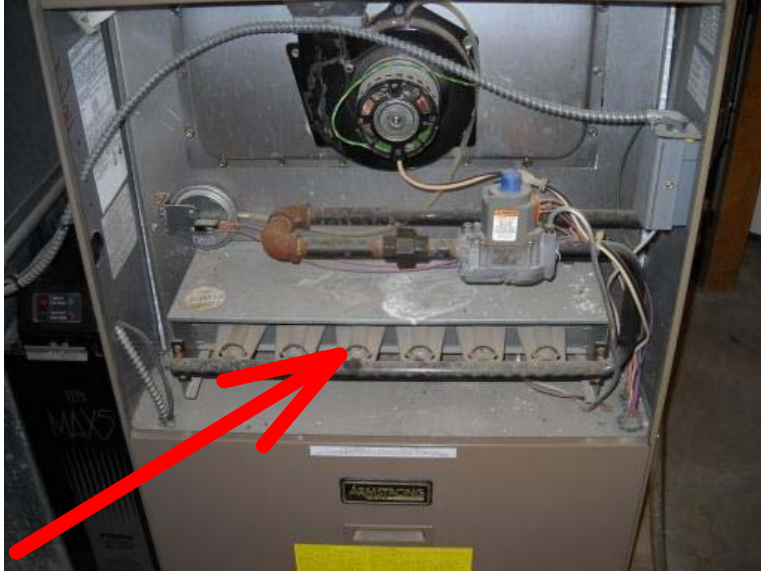
The furnace in the basement is short cycling during the function testing of the unit. Recommend having a qualified contractor evaluate and repair per recommendations.
